SAFE OPERATION OF FIRE TANKERS

U.S. Fire Administration

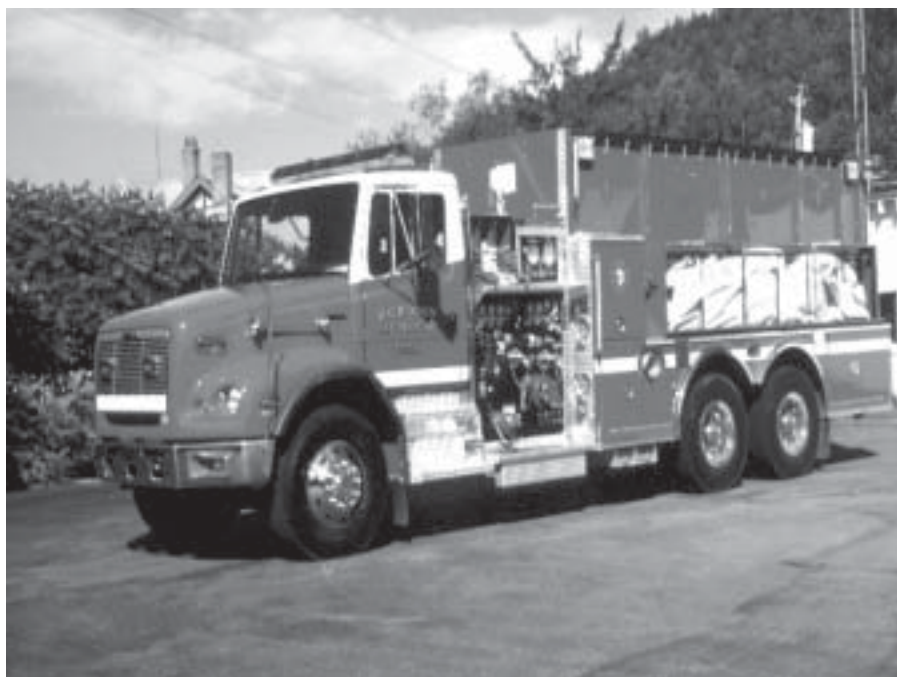
Figure 1-8 Some tankers, by design, have a high center of gravity. *Courtesy of Ron Bogardus*

Vehicles that have a high center of gravity are dangerous from several standpoints related to the driver’s ability to control the vehicle. Top-heavy vehicles have a tendency to want to tip over if they are driven through a curve at an unsafe speed. This tendency is a matter of simple physics involving inertia and momentum. As the vehicle negotiates the turn in one direction, momentum and inertia cause the weight of the vehicle to lean in the opposite direction to which the vehicle is turning (in reality *toward* the same direction the vehicle was traveling before the curve was started). If the speed of the vehicle is too great, this inertia may cause the vehicle to leave the road or roll over toward the outside of the curve (**Figure 1-9**).

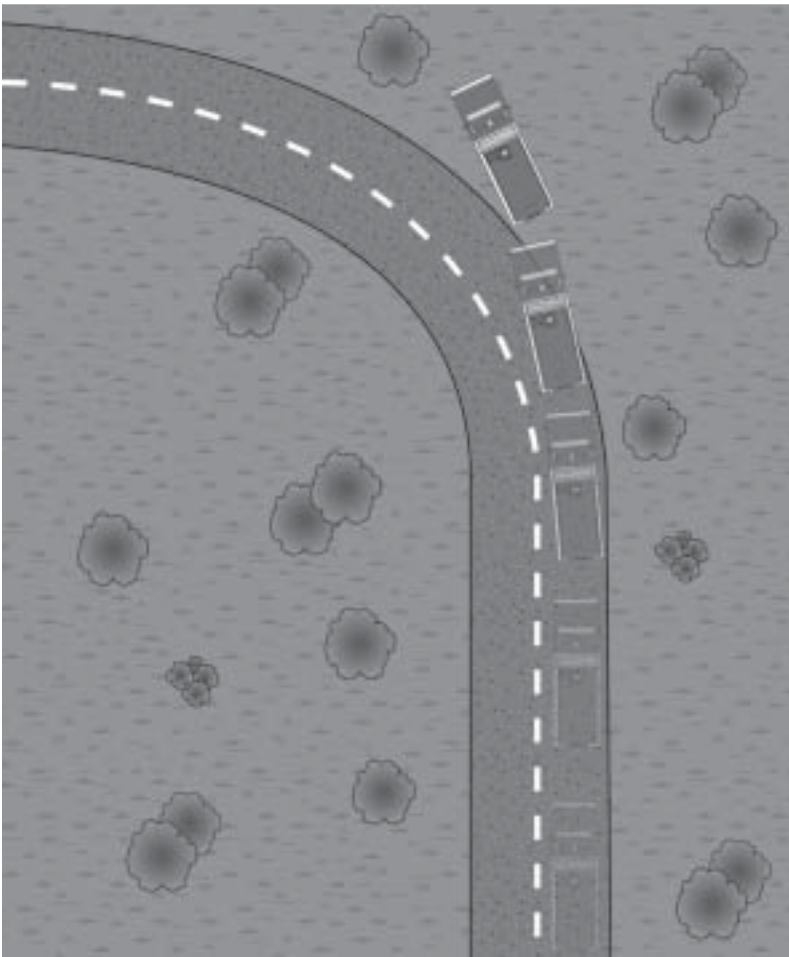
Figure 1-9 Inertia may cause the tanker to exit the roadway to the outside of the curve.

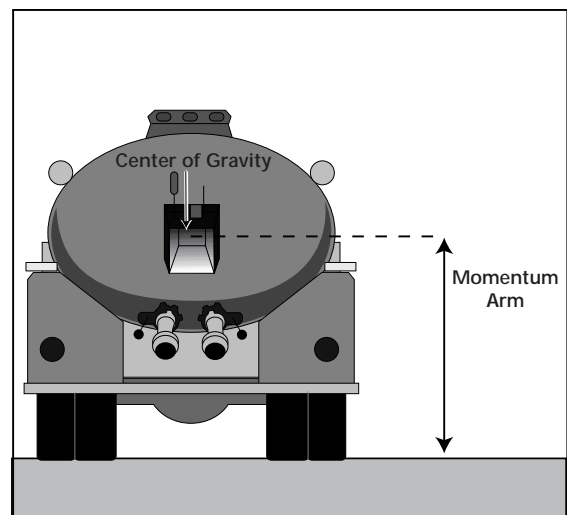
Figure 1-10 The arm extends from the tanker's momentum center of gravity down to the road surface.

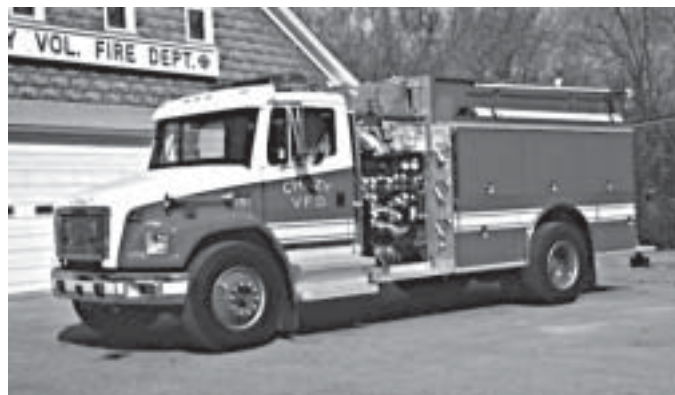
Figure 1-11 Tankers with T-shaped tanks and single rear axles should be limited to 1,500 gallons of water. *Courtesy of Ron Bogardus*

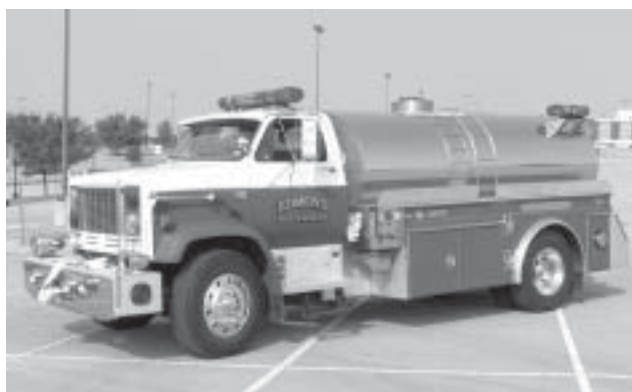
Figure 1-12 Tankers with elliptical tanks and single rear axles should be limited to 2,000 gallons of water.

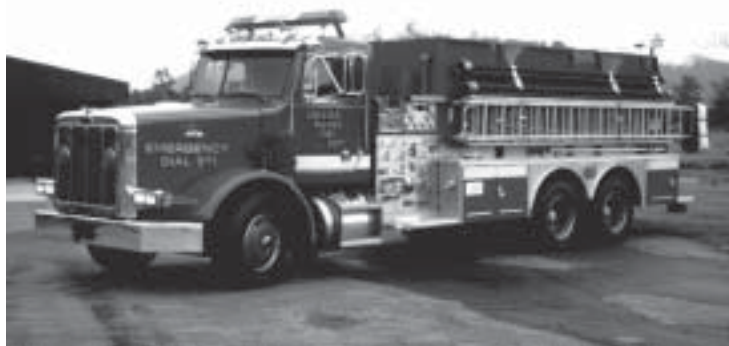
Figure 1-13 Straight chassis, tandem-axle tankers may carry as much as 4,000 gallons of water.

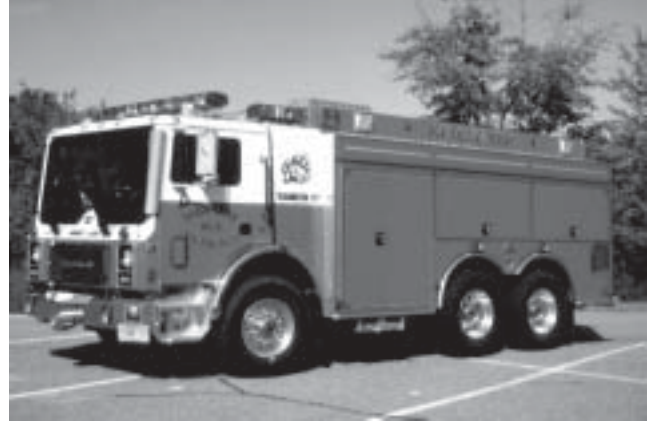
Figure 1-14 Tankers with shortened wheelbases tend to have higher centers of gravity. *Courtesy of Ron Jeffers*

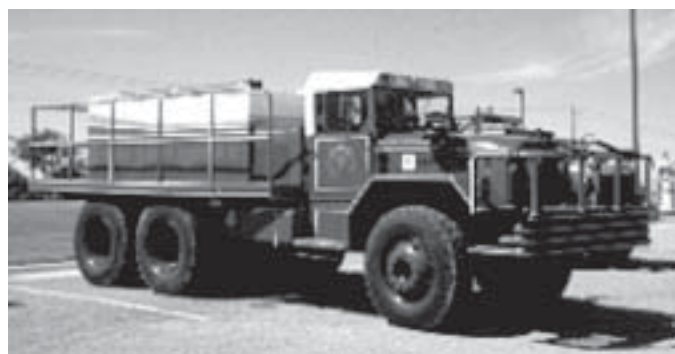
Figure 1-15a A military 6x6 vehicle converted into a fire department tanker.

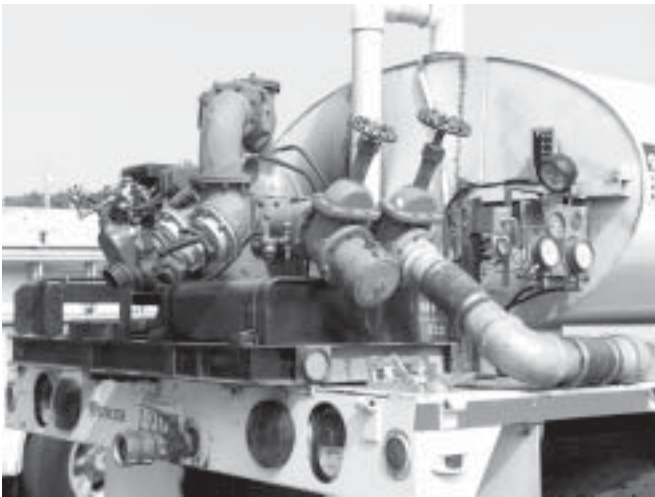
Figure 1-17 Pumps and piping can add a considerable amount of weight to the apparatus.

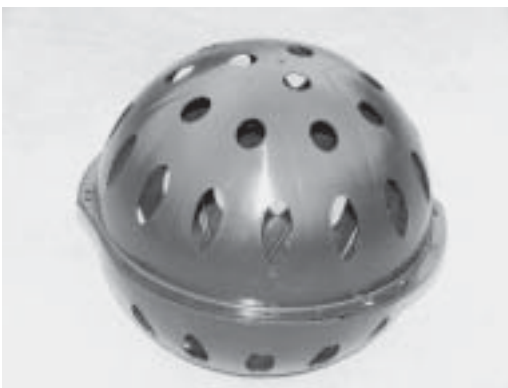
Figure 1-18a A baffle ball. Courtesy of Snow Equipment Sales

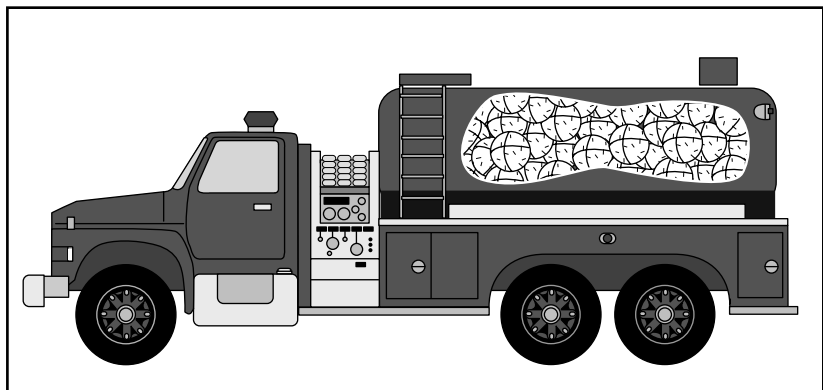
Figure 1-18b Baffle balls are inserted into the tank through the tank vent. Courtesy of Snow Equipment Sales

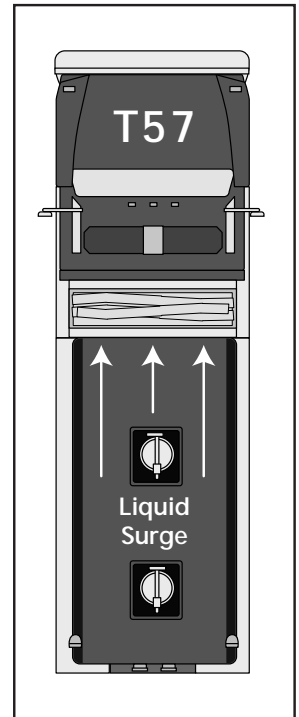
Figure 1-19 Liquid surge can work to propel the vehicle forward.

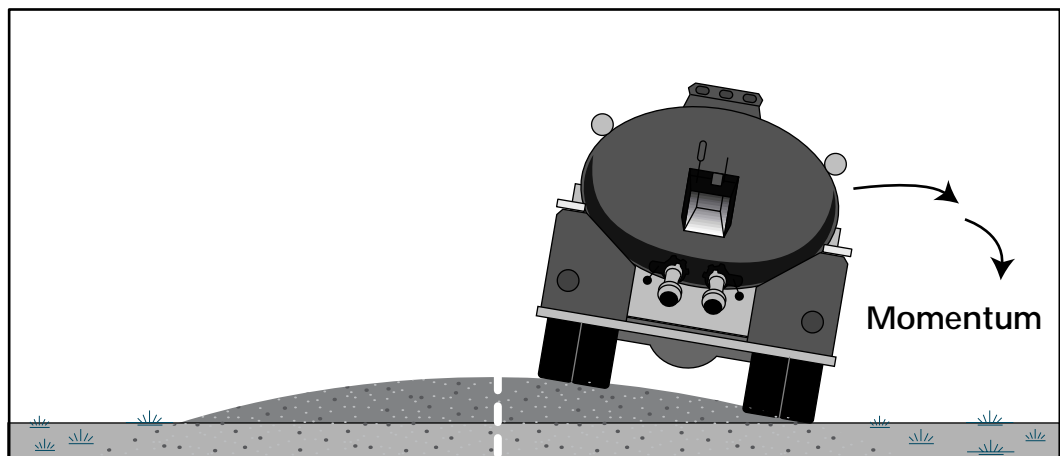
Figure 1-20 An excessive crown on the road may tend to cause the tanker to lean towards the shoulder.

- *Roads with high center crowns* -- Roads are often designed with a crown in the middle to facilitate water runoff during rainy weather. However, sometimes the center crown of the road is so elevated that vehicles driving on it have a considerable amount of lean toward the outside of the road (**Figure 1-20**). This makes it more difficult to handle any vehicle driven on that surface. It is particularly hazardous for tankers with improper baffling or high centers of gravity. The outward lean of the driving surface will increase the vehicle's tendency to want to tip over.

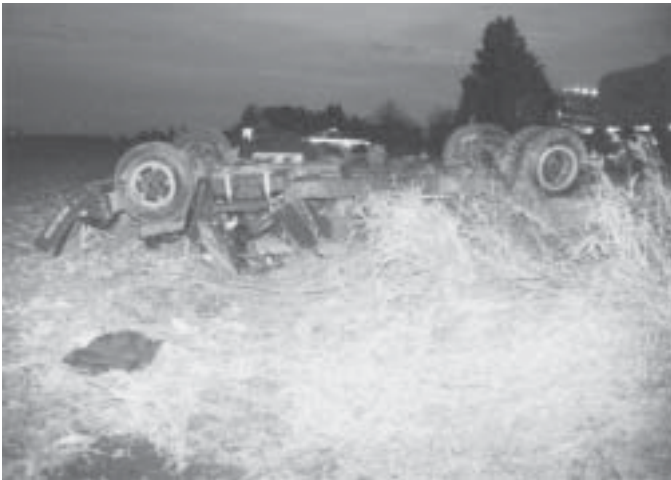
Figure 3-1 The water tank separated from the chassis after the vehicle left the roadway.

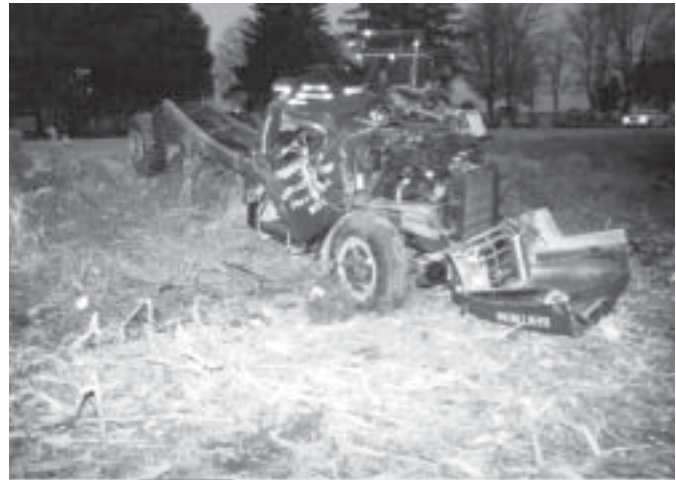
Figure 3-2 Occupants required extrication from the crushed cab.

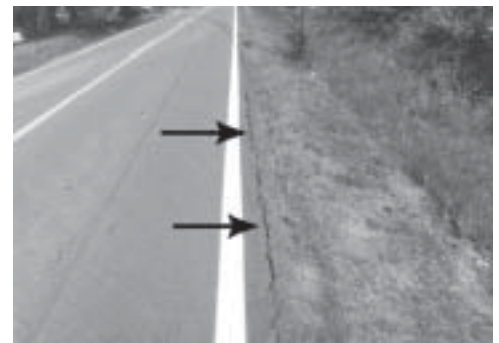
Figure 3-3 Note the cracks in the asphalt at the road's edge.

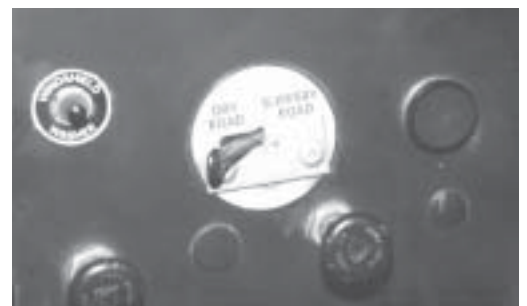
Figure 4-4 Wet/Dry road switches should be left in the dry road position at all times.

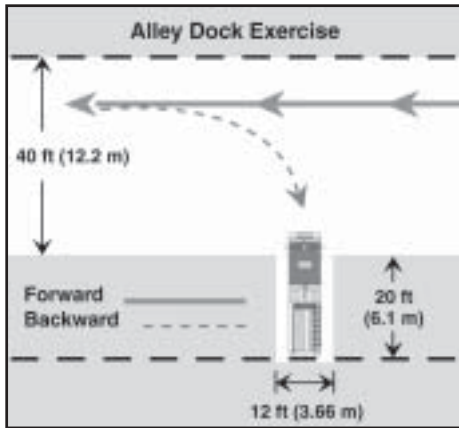
Figure 4-6 The Alley Dock Exercise. Courtesy of IFSTA/Fire Protection Publications

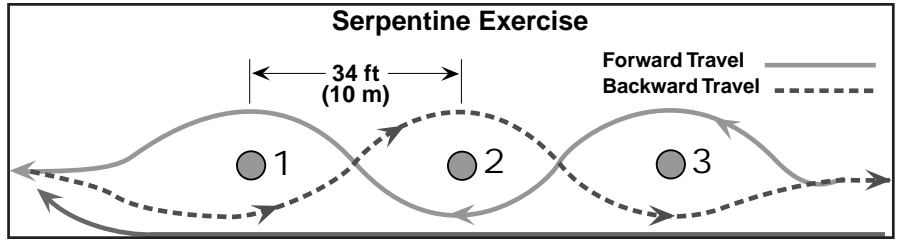
Figure 4-7 The Serpentine Exercise. Courtesy of IFSTA/Fire Protection Publications

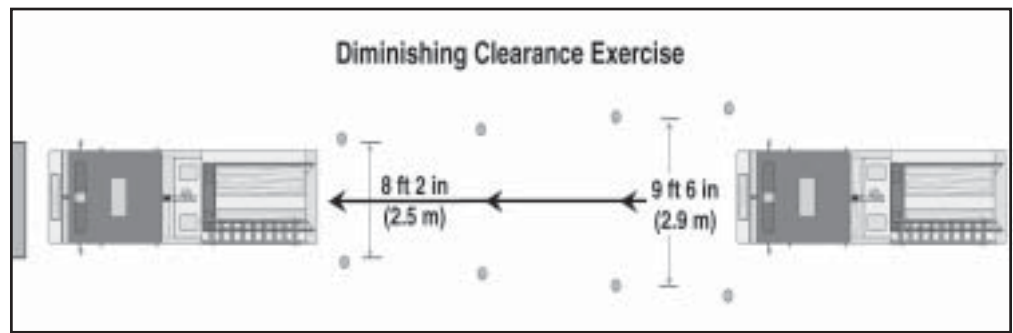
Figure 4-9 The Diminishing Clearance Exercise. Courtesy of IFSTA/Fire Protection Publications

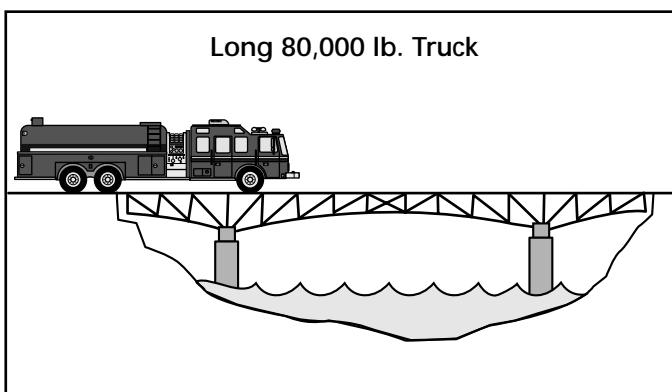
Figure 4-12a By spreading the weight out over a long chassis, there is less stress placed on the bridge.

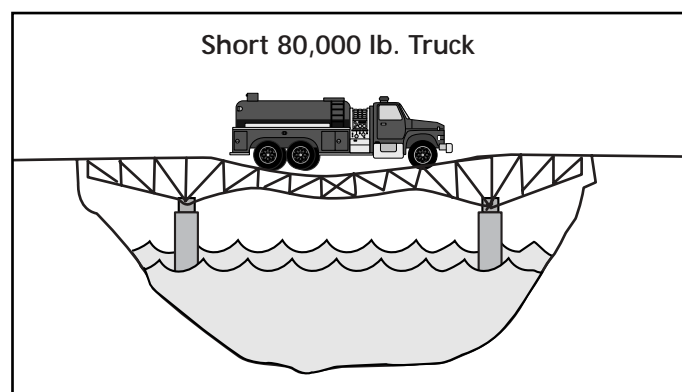
Figure 4-12b An excessive amount of weight on a short chassis may overstress a bridge.

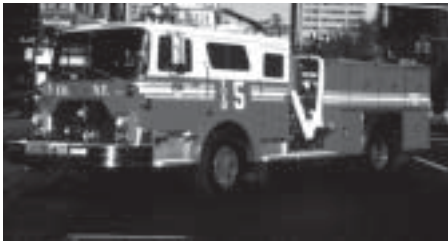
Figure 4-13 In this case, the FDNY converted pumpers that originally carried 500 gallons of water to foam tankers that carry 1,000 gallons of foam concentrate. This conversion did include chassis and brake system upgrades.
Courtesy of Ron Jeffers

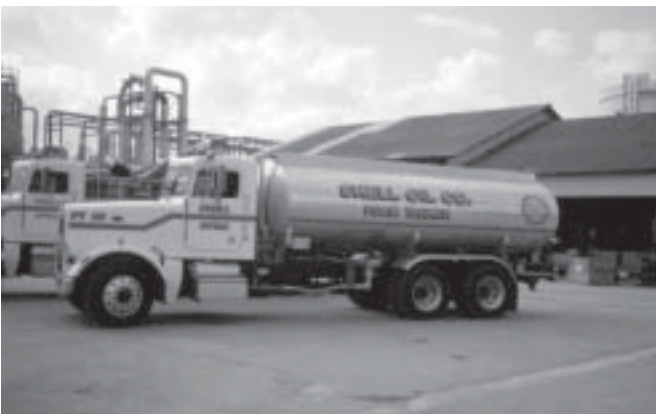
Figure 4-16 Although not always the case, one sign of an overloaded chassis is excessive sagging of the body over the rear wheels.

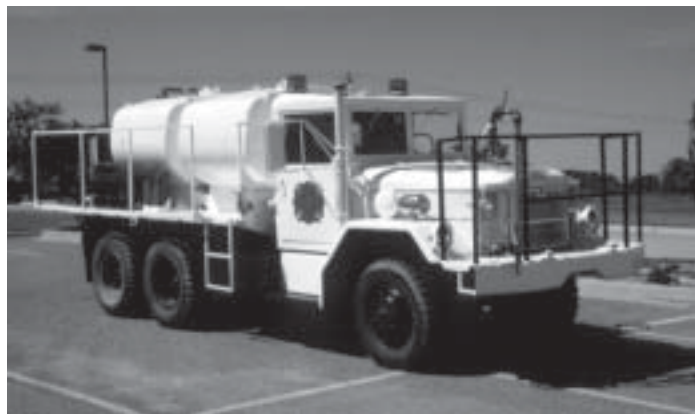
Figure 4-17 Note that the cradle legs between these tanks and the truck bed actually raise the vehicle's center of gravity even further.

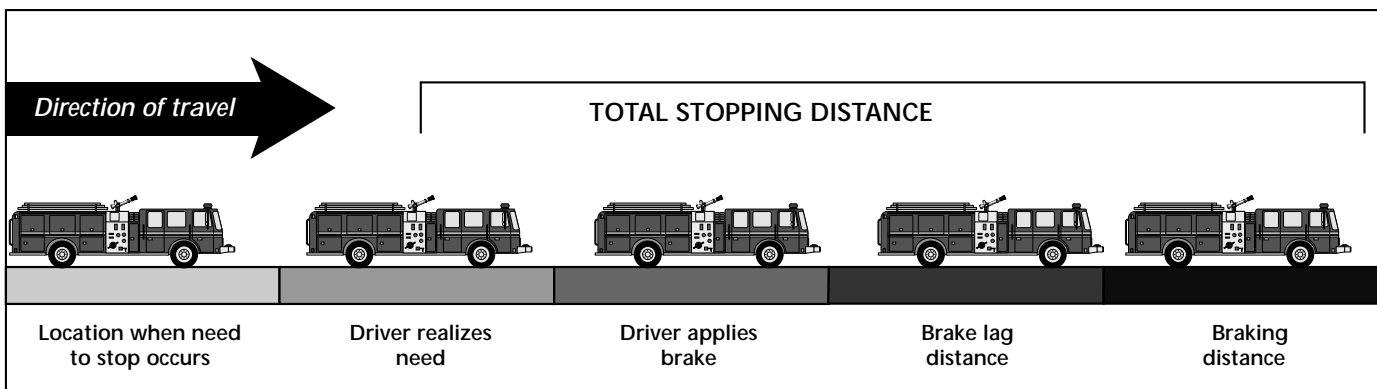
Figure 4-23 A diagram of the total stopping distance for a vehicle. Note that in reality these portions are not equidistant.

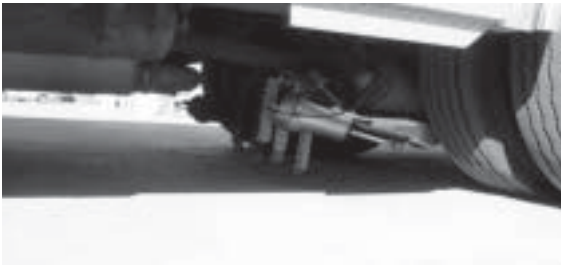
Figure 4-27 Automatic tire chains work fairly well in snow up to about 6 or 8 inches deep.

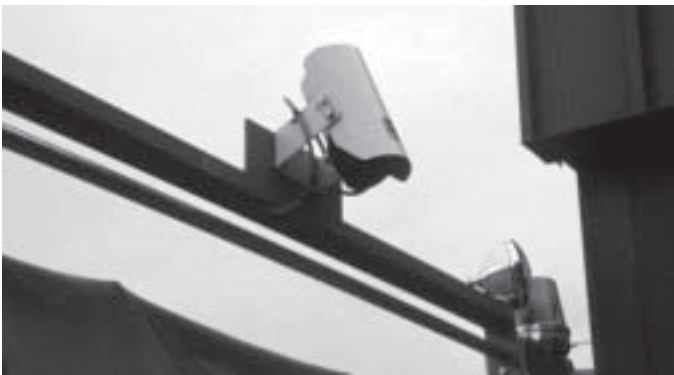
Figure 4-32a A camera is mounted on the rear of the apparatus.

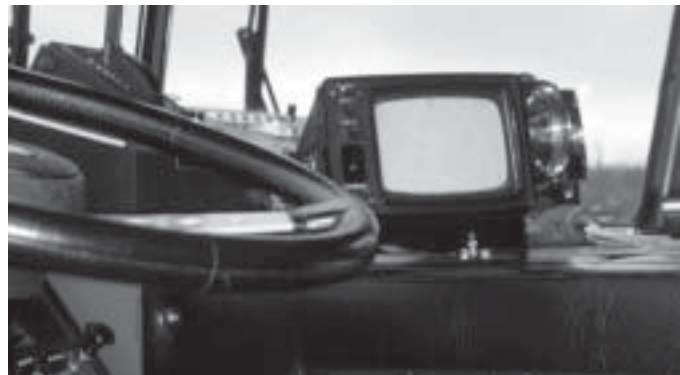
Figure 4-32b The monitor in the cab allows the driver to view the area behind the apparatus.

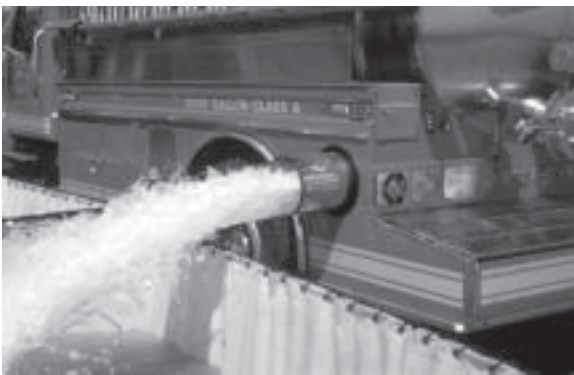
Figure 4-36 Side dumps require the least positioning of apparatus at the dump site.

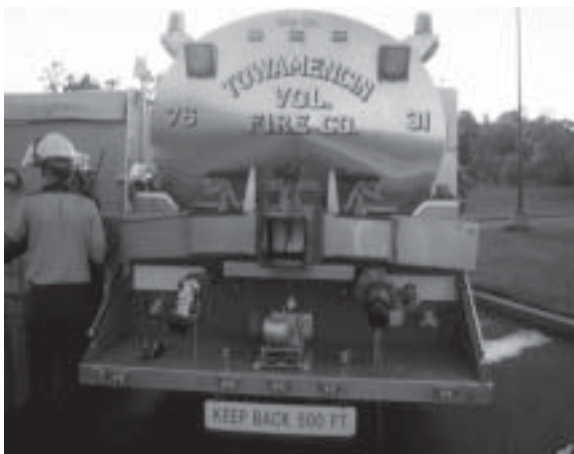
Figure 4-37 Rear dumps may be modified to discharge to either side of the apparatus.
